# HONE TUWHARE CRIB

1346 KAKA POINT ROAD, KAKA POINT,  
SOUTH OTAGO

## CONSERVATION PLAN

AUGUST 2014

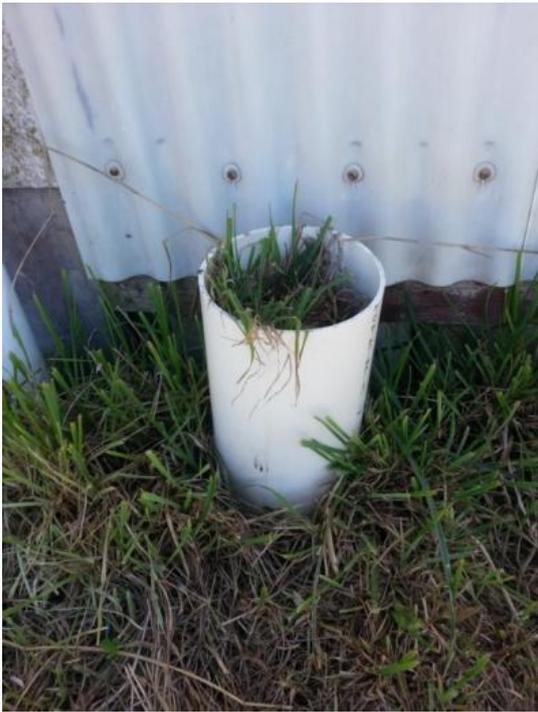
Figure 75. Old downpipe connection (left) Figure 76. Sheet connection detail (right),) Photographs: LK March 2014.

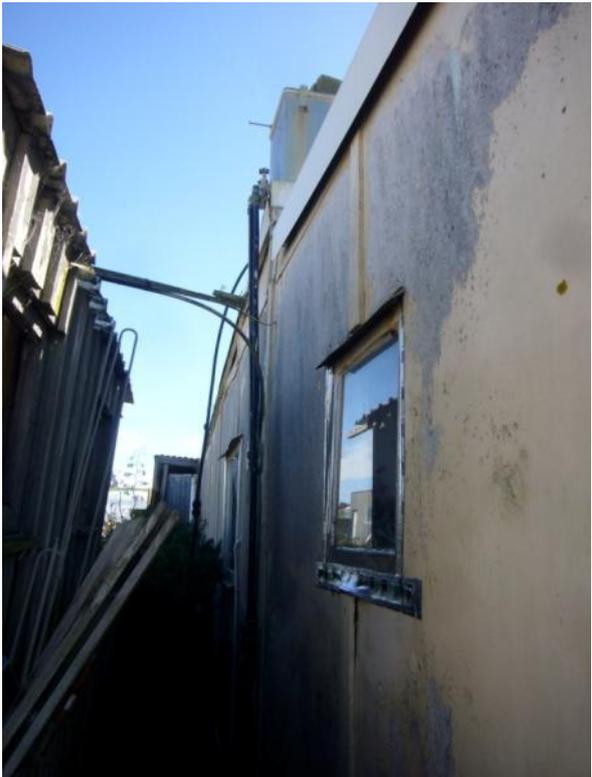
Figure 97. South wall, view west, showing pipes between crib and neighbouring shed (left) Figure 98. Kitchen window detail, showing temporary weathering repairs (right), GB March 2014

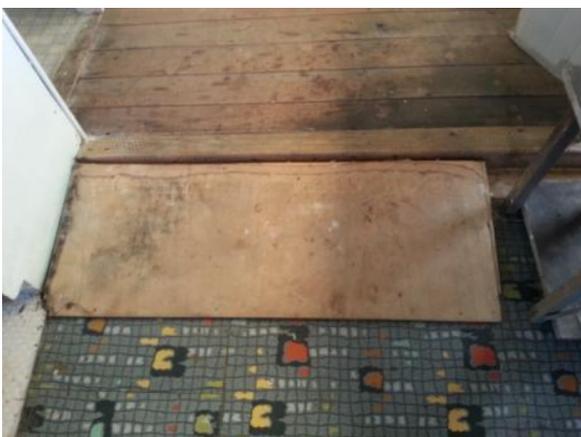
Figure 123. Linoleum patchwork on kitchen floor (left) Figure 124. Electrical socket detail below window on east wall (right) LK March 2014

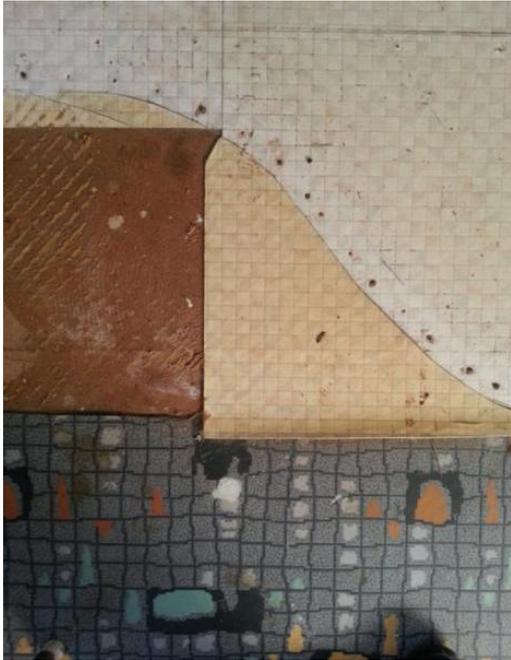
Figure 124. Linoleum patchwork on kitchen floor (left) Figure 125. Electrical socket detail below window on east wall (right) LK March 2014

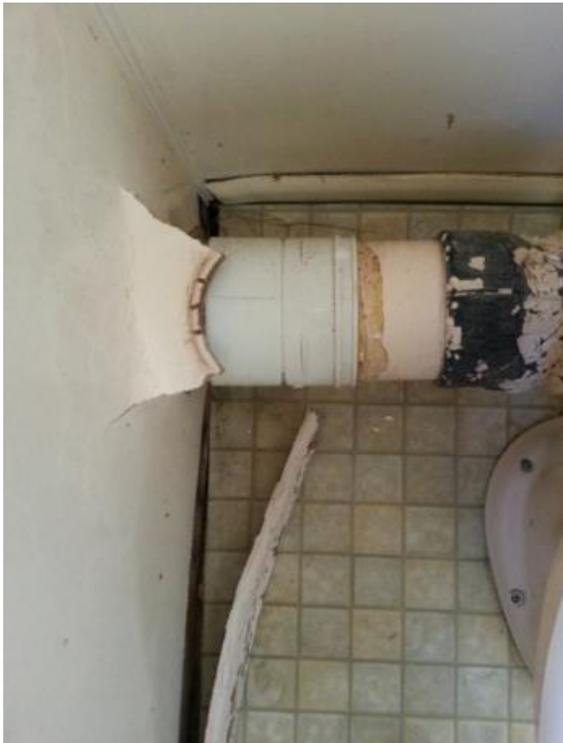
Figure 174. Pipe from WC & peeling skirting board (left) Figure 175. Bathroom south west corner (right) LK March 2014
