# HONE TUWHARE CRIB

1346 KAKA POINT ROAD, KAKA POINT,  
SOUTH OTAGO

## CONSERVATION PLAN

AUGUST 2014

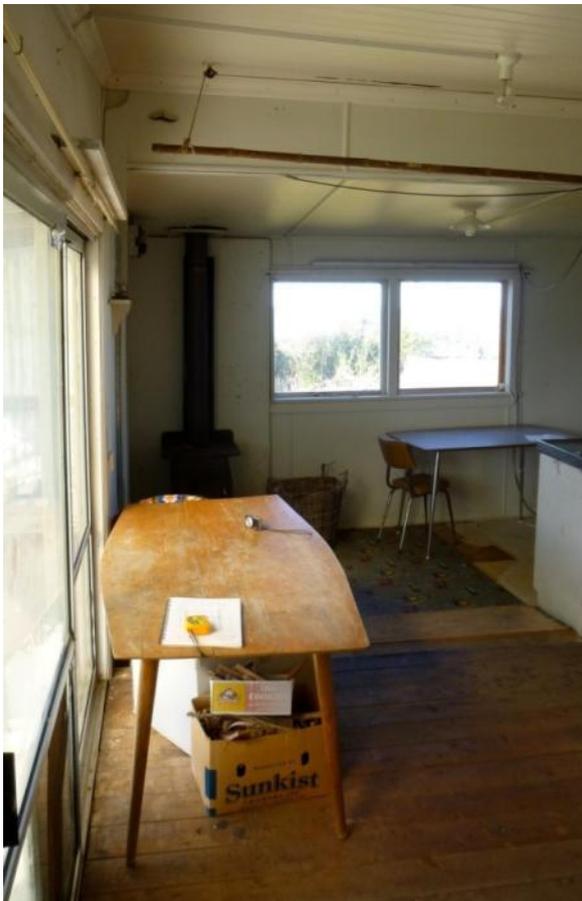
The fixing holes in the cornice are not filled. The floor in this area is t + g timber running across the room (north / south). An aluminium “ranch slider” has been fitted in the external wall, the north wall. This is the only entry to the crib. The substructure has slumped at the line of the bedroom wall.

Figure 106. View through living area into kitchen from bedroom (left) Figure 107. Ranch slider door detail (right) GB March 2014

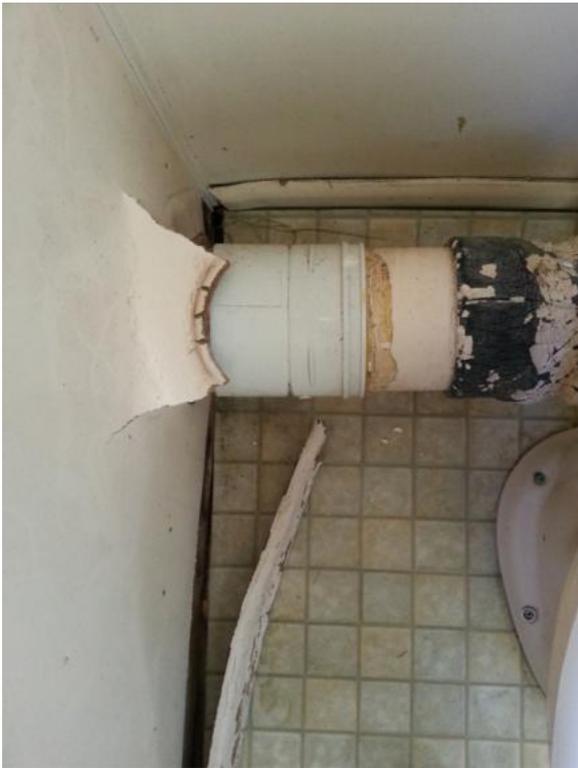
Figure 112. Pipe from WC & peeling skirting board (left) Figure 113. Bathroom south west corner (right) LK March 2014

The toilet is at the south west corner, on the west wall. This is a ceramic pan and plastic cistern. The pan has a side outlet that has been crudely forced through the wall. The toilet is pale pink, matching the wall colour.

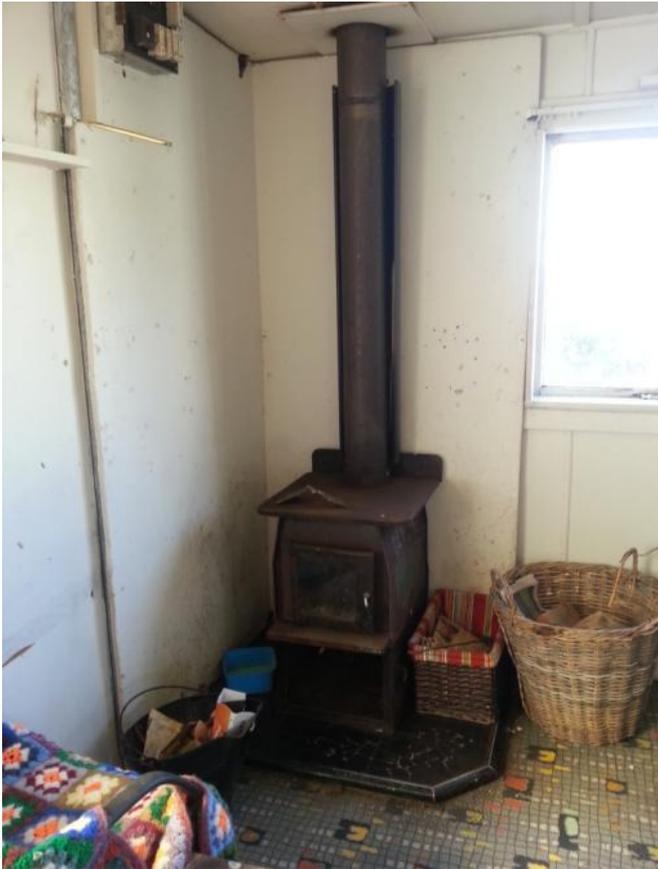
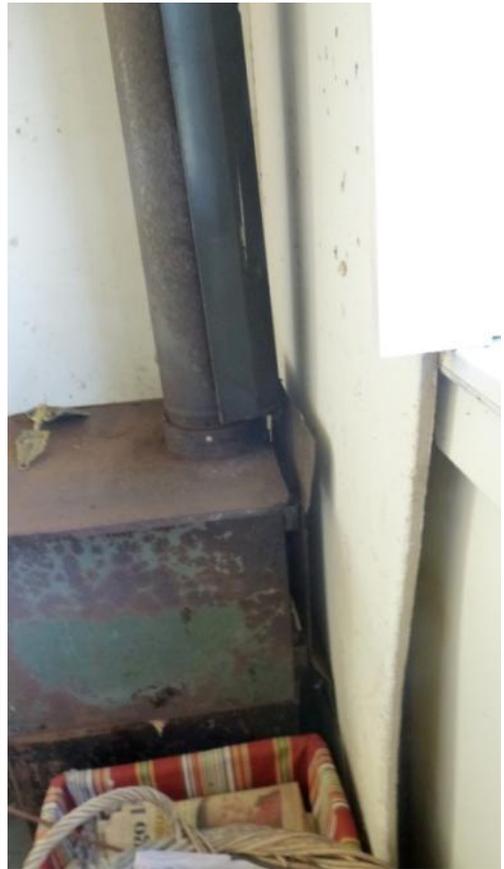
Figure 119. North east corner of kitchen area showing wood burner (left) Figure 120. Wood burner detail (right) LK March 14

At the north east corner, set to the corner, is a rectangular, free standing, wood burning stove. The stove is set on a small plastered plinth with a large  $\frac{1}{4}$  round base moulding to the edges. Behind the stove, on both walls are panels of rough cut fire rated material, set out from the old wall linings that remain in place behind.

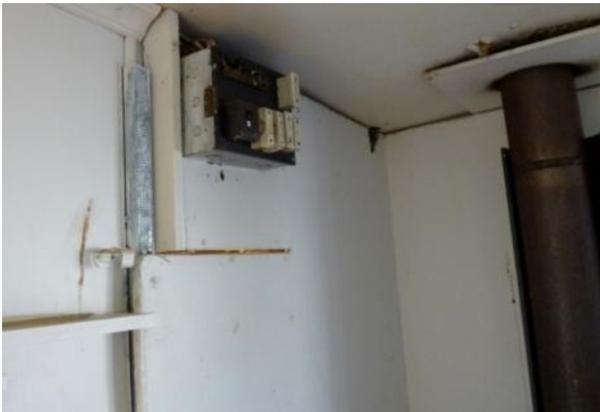
Figure 121. North east corner of kitchen area showing electrical switch board and flue from wood burner (left) Figure 122 Shelf on north wall (right) LK March 2014

The panels stop short of the ceiling. The panel on the north wall has been cut around the fuse board, which sits at ceiling level at the top left hand corner of the panel. The panel also covers a window on the north wall, which has been left in place

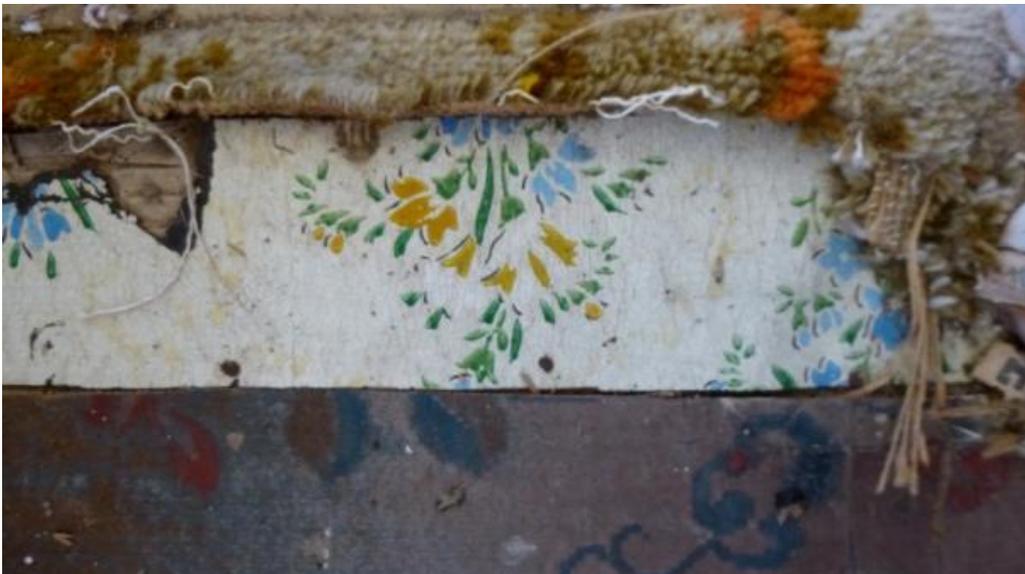
Figure 142. Layered flooring in bedroom, GB March 2014

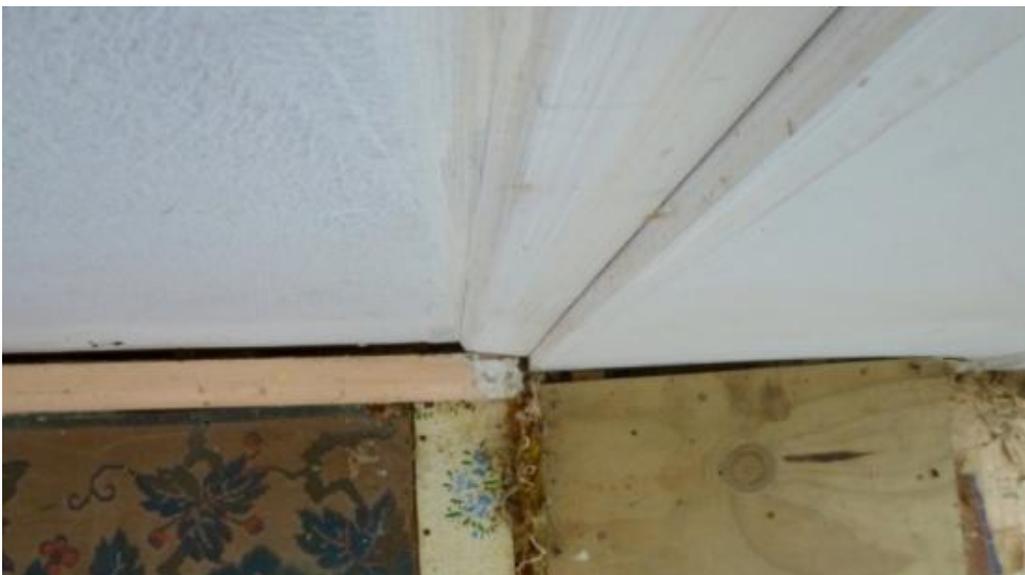
The doorway to the bedroom is at the north west corner of this room, on the west wall. There is no door, only a surface mounted curtain track. The bedroom is slightly higher than the living area and a crude ramp of plywood fixed over sections of carpet, linoleum and old newspapers has been constructed at this threshold. The doorway slumps badly to the left and the wall lining has opened where the structure has failed. At the south end of this wall (the western wall of the room) a small rectangular opening has been cut at the top of the wall into the bedroom. The opening is not finished in any way on this side.

Figure 143. Ramped floor into bedroom at doorway, GB March 2014

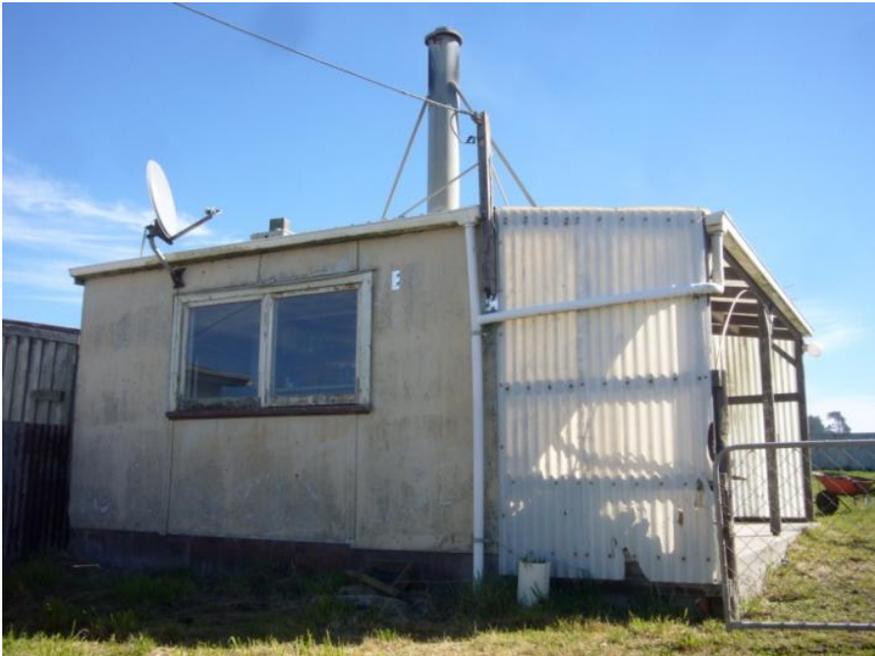
Figure 161. East Elevation of the crib, LK March 2014

The sheeting is cracked and broken in places. At the intersection with the vertical hardwood batten that holds the power connection (east elevation), the movement of the batten, which has rotted at the base, has caused the cladding to crack.

Neither of the windows on the south side are functioning. The east window similarly is in poor condition. The opening sash of this window still functions. The Sky cable has been drilled through the bottom corner of the fixed sash.

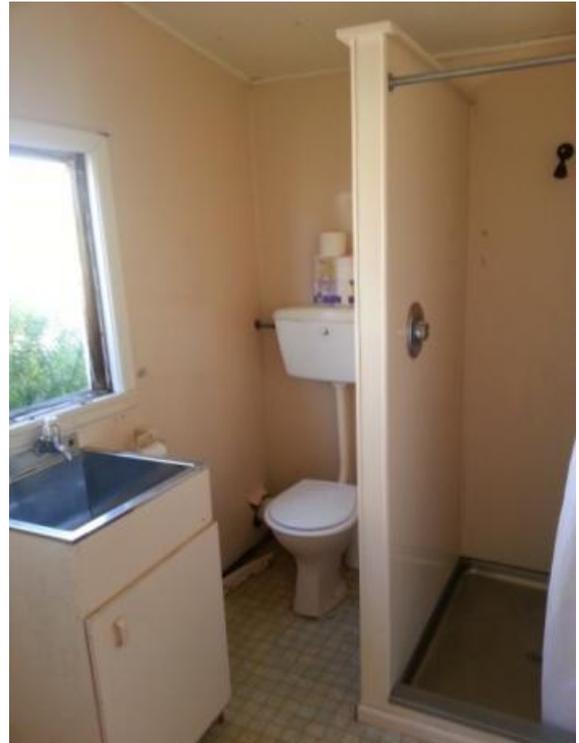
Figure 174. Pipe from WC & peeling skirting board (left) Figure 175. Bathroom south west corner (right) LK March 2014

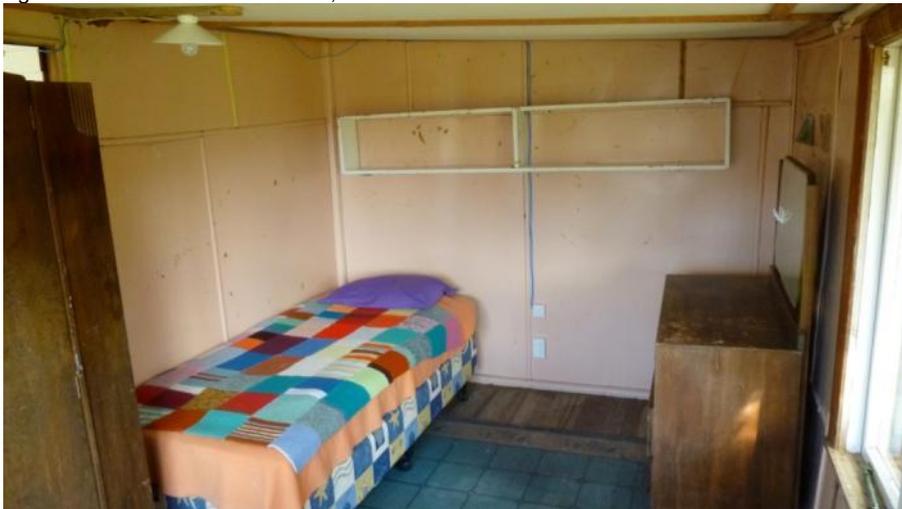
Figure 183. South wall of bedroom, GB March 2014

Before the roof was repaired the crib leaked. This has affected the condition of the interior. The base of the wall linings at the south west corner of the bedroom (and up the south wall) are buckled and show signs of water damage and possible decay. There is staining on the interior linings.

The floor in the bedroom is bowed. At the south west corner there are signs of water damage. The strip timber flooring (running north/south across the room) appears to be in good condition.

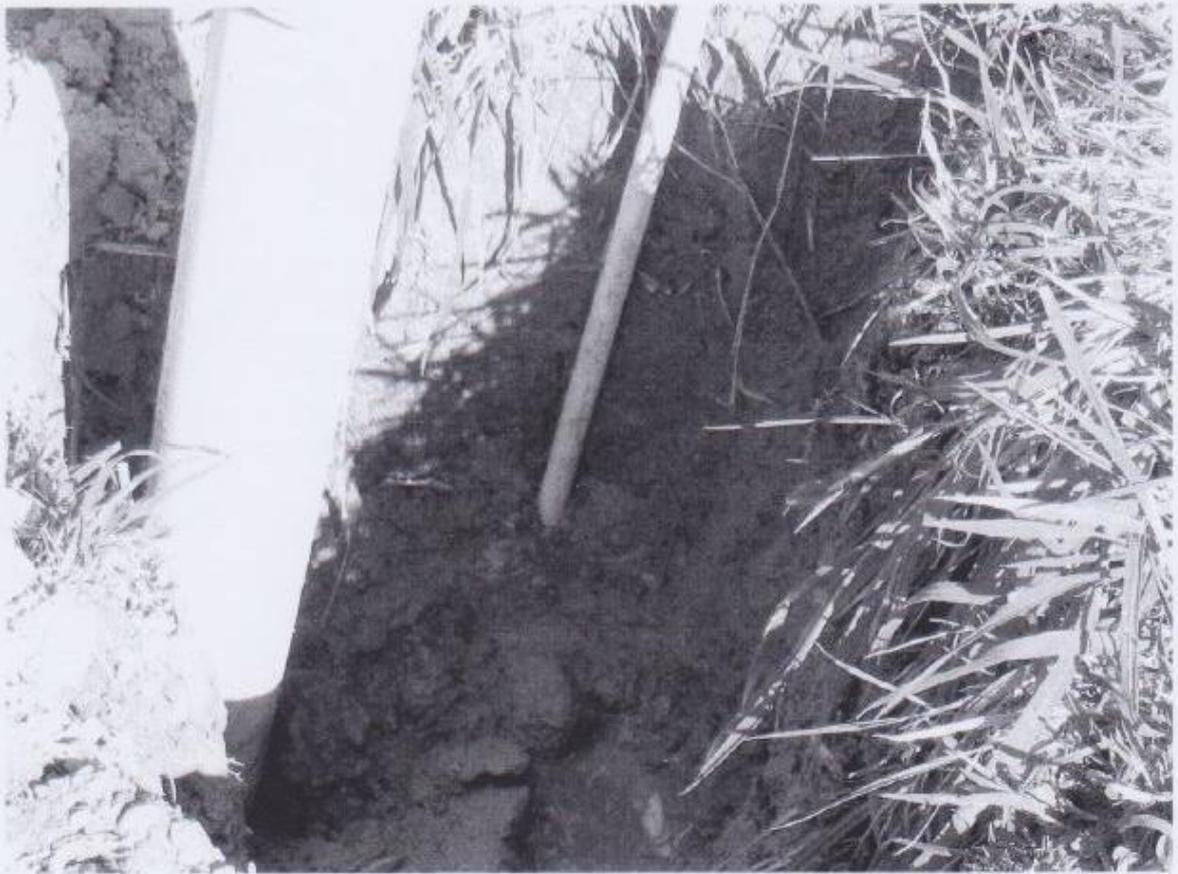
Visited on 16/10/03 - septic tank had  
filled up again, and water was  
flowing down side of house beside  
fence. Tested water where it flowed  
near septic tank vent - DPD1 tab  
was strongly positive for free chlorine  
RJA discussed with Paul Stattery -  
Fintan Hogan to visit & repair.  
WShan/16/10/03.
